Subject: On-Call Asbestos, Lead, Air Quality & Demolition Compliance
Agreement No.: 8.07-01 (18)
HazMat Inspection - Bridge Nos. 03176 & 03177 (Site Nos. 1 & 2), Route 8 SB & NB over
Naugatuck River, Waterbury, CT
ConnDOT Assignment No. 519-6094
ConnDOT Project No. 151-333
TRC Project No. 289951.6094.0710

TRC performed a limited survey for hazardous building materials associated with the rehabilitations of Bridge Nos. 03176 & 03177 (Site Nos. 1 & 2), Route 8 SB & NB over Naugatuck River in Waterbury, Connecticut. Results of the survey identified no detectable amounts of lead in paint to be present on the structural steel/metal bridge components and concrete surfaces of Bridge Nos. 03166 & 03177. Since there were no detectable amounts of lead in the paint on any bridge surfaces, any potential waste stream would be non-hazardous, non-RCRA waste. Brittle white caulking between the metal railing supports and parapets walls at Bridge Nos. 03176 & 03177 was found to contain asbestos. Also, black insulation/coating on the west side of Bridge No. 03176 is presently presumed to contain asbestos. Other suspect caulking & bridge tars under the bridges were sampled and found to be non-detect

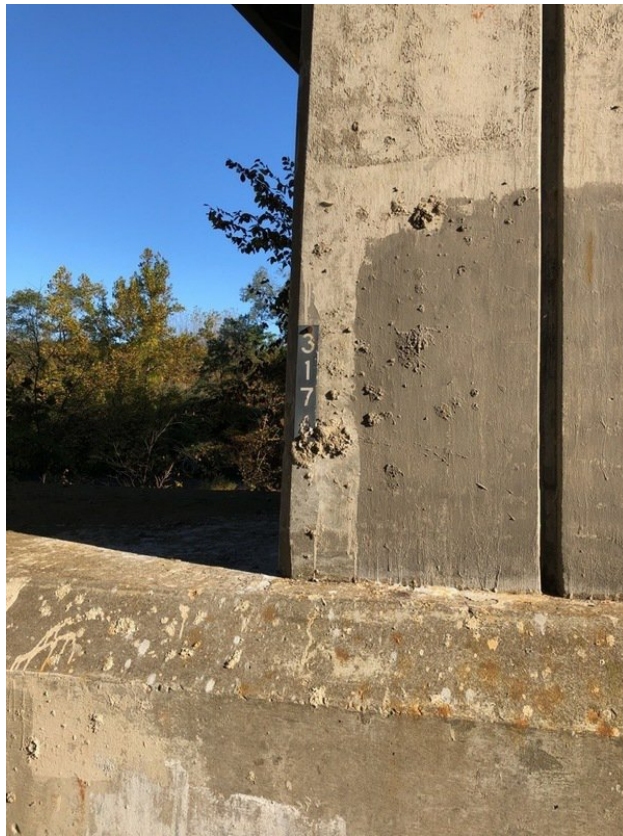
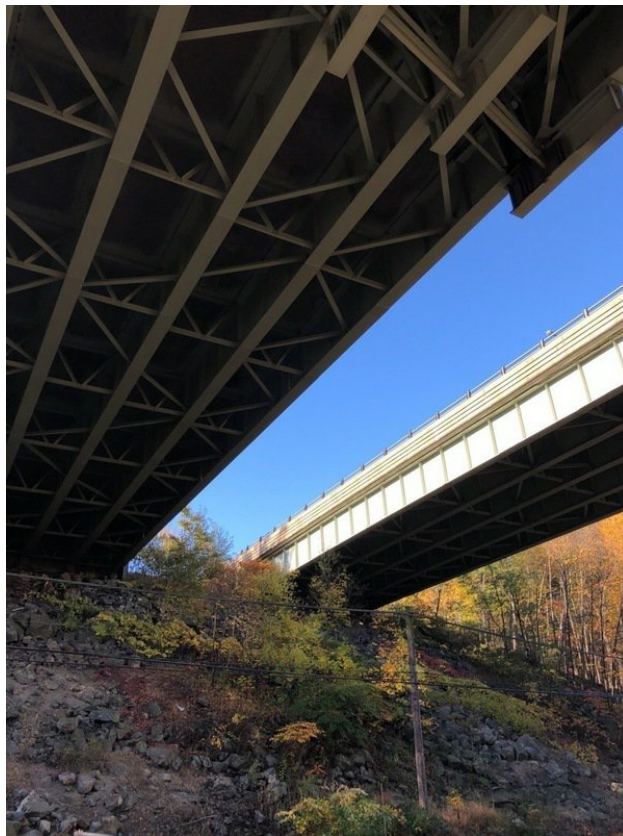
South side

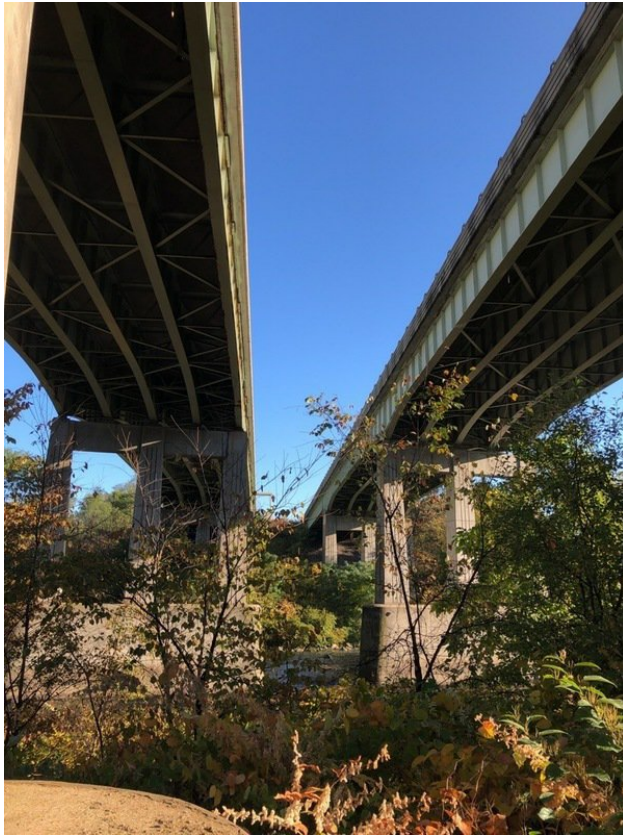
North side

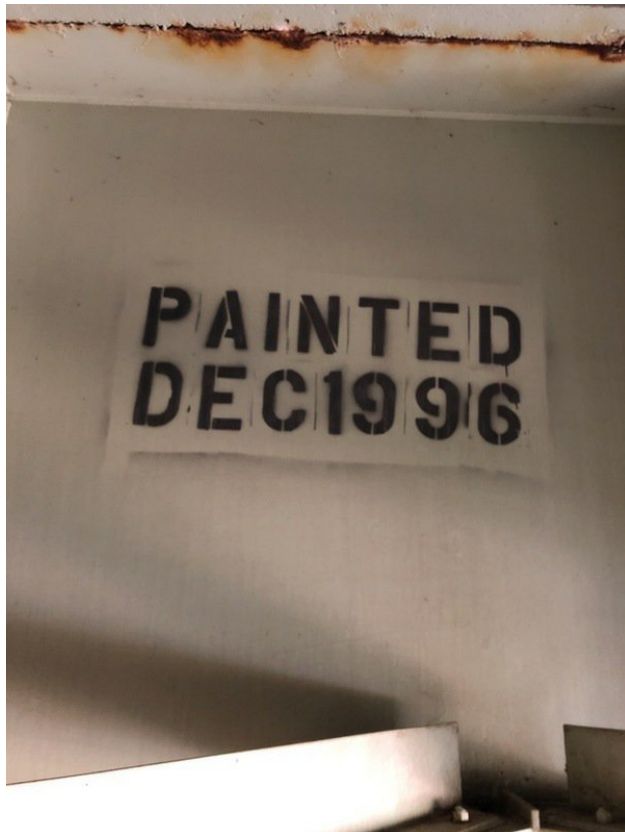
Underneath 03176

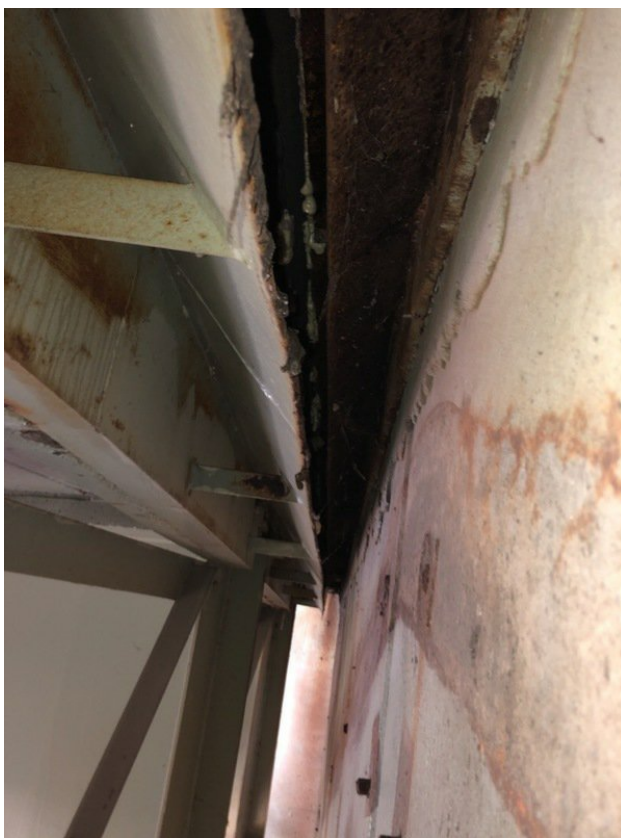
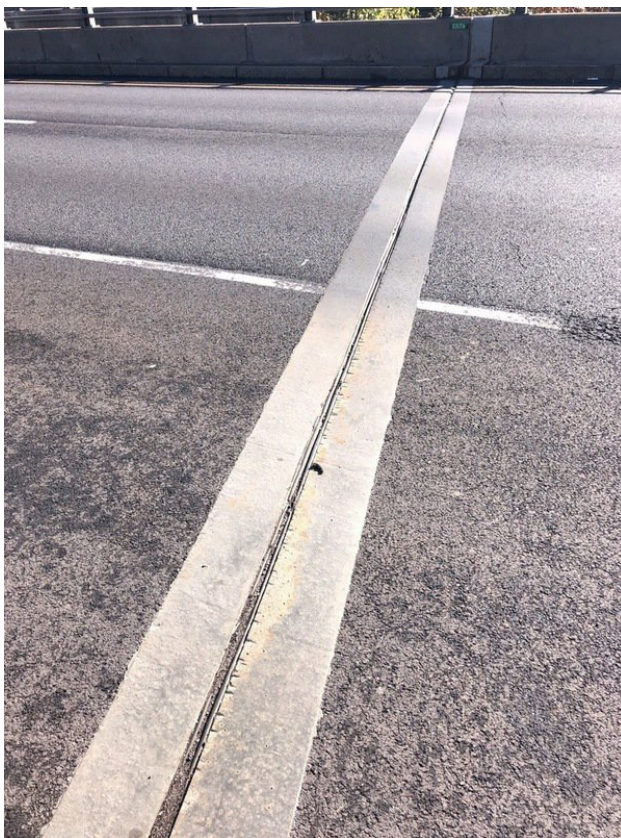
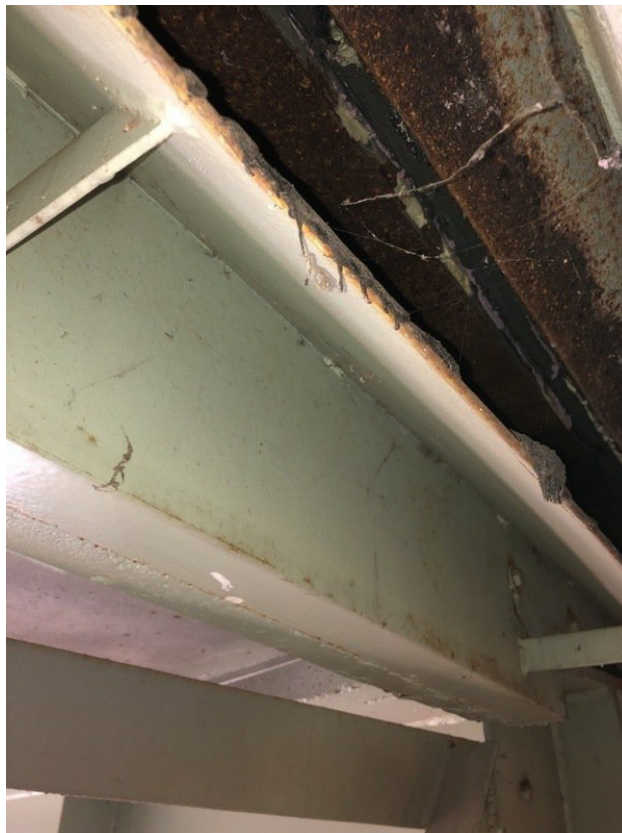
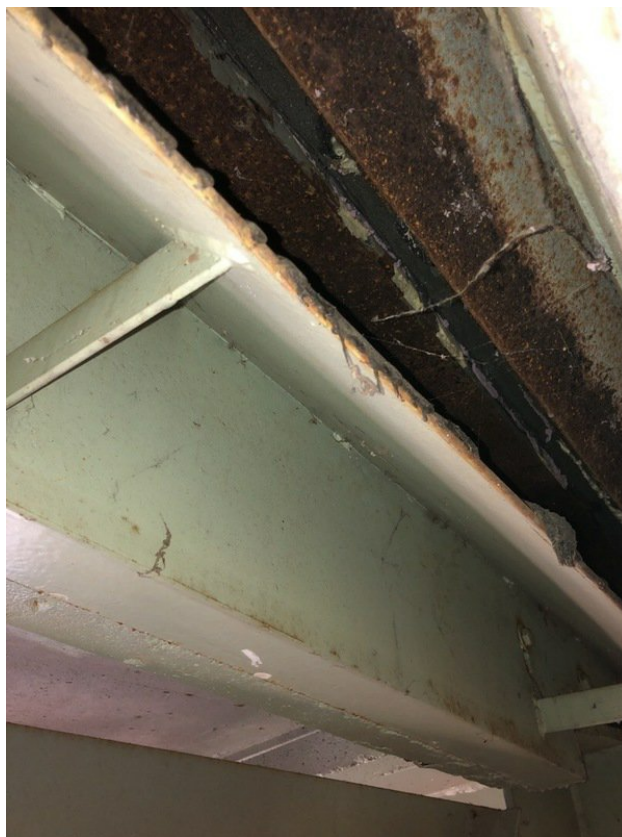
Under bridge #03176

(2), C, 1, Black, hard tar , 2

Sampled or Assumed?	Sampled
Material Acronym	C, 1
Material Description	Black, hard tar
Is Material a Non-Friable Organically Bound (NOB)	Yes
Homogeneous Area	Along the top and underside of both bridges where bridge meets road, assumed on other side in same location.
Total Approximate Quantity	250 LF
Total Count	(2)
Total Count (number only)	2

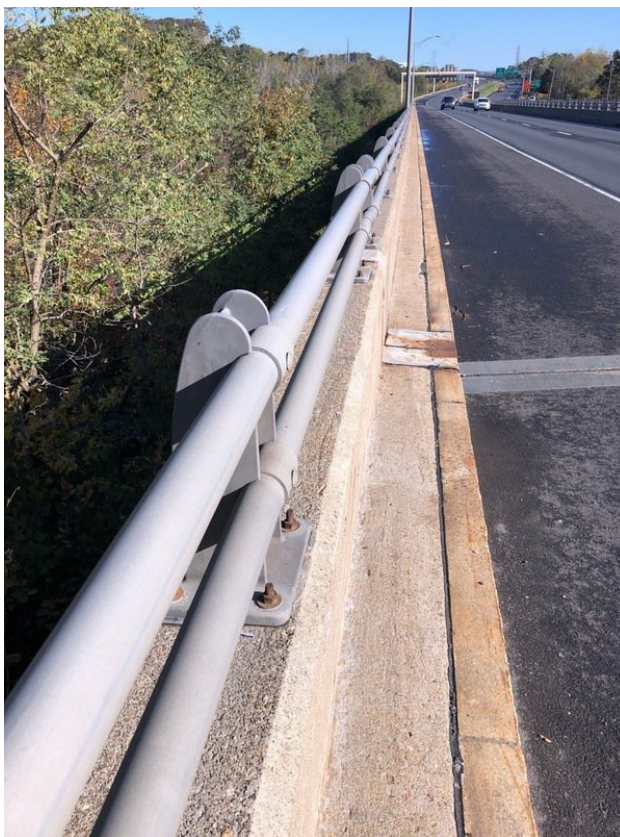
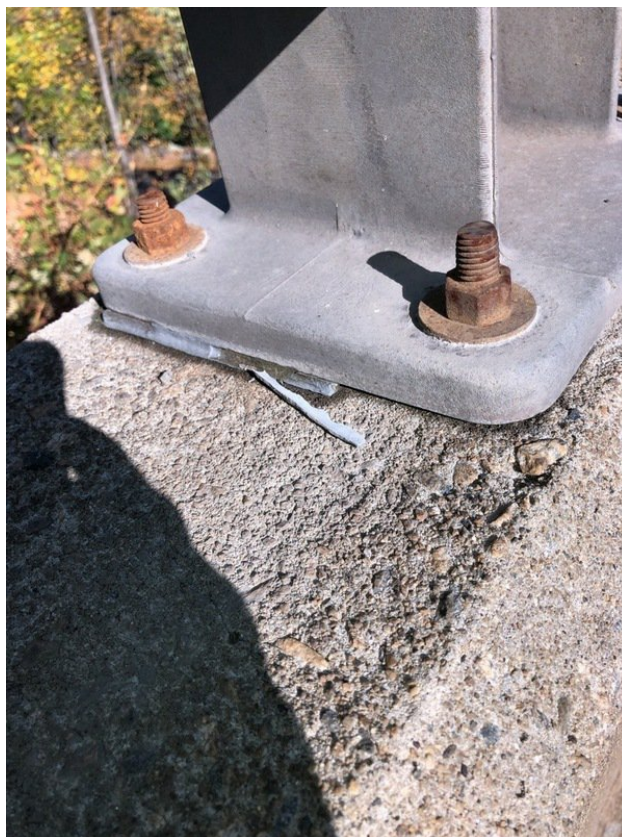
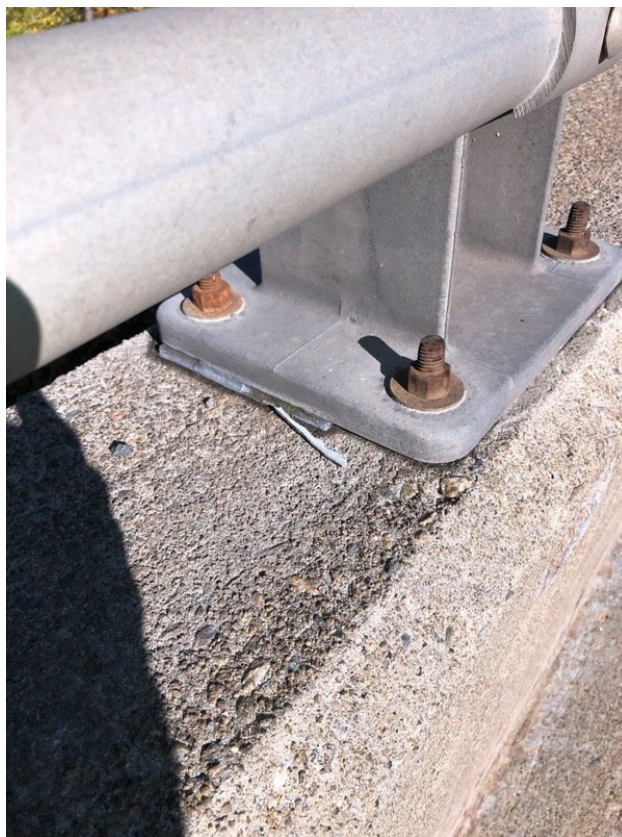
Route 8 south

(2), C, 2, White, brittle guardrail caulking, 2

Sampled or Assumed?	Sampled
Material Acronym	C, 2
Material Description	White, brittle guardrail caulking
Is Material a Non-Friable Organically Bound (NOB)	Yes
Homogeneous Area	Under every guardrail pedestal on bridge
Total Approximate Quantity	340 guardrail pedestals, each 1' x 1'
Total Count	(2)
Total Count (number only)	2

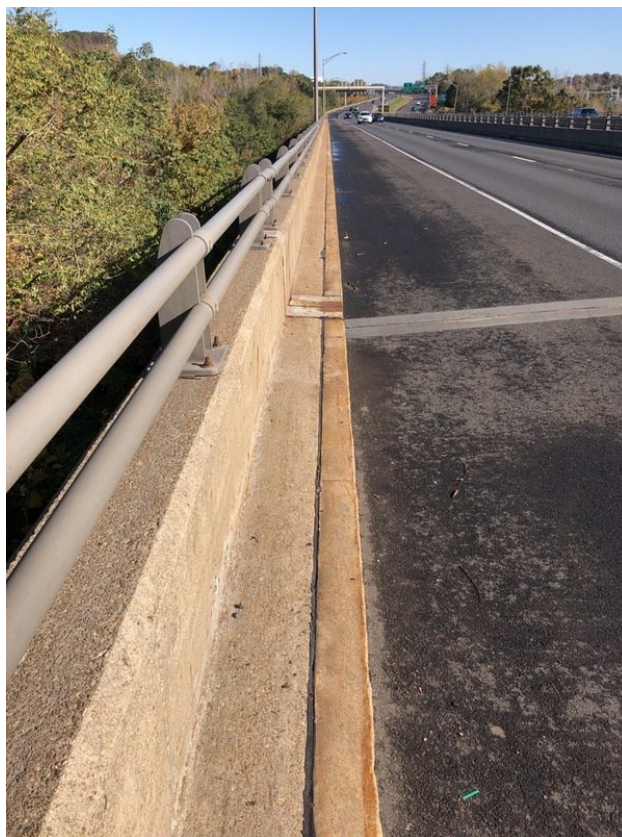
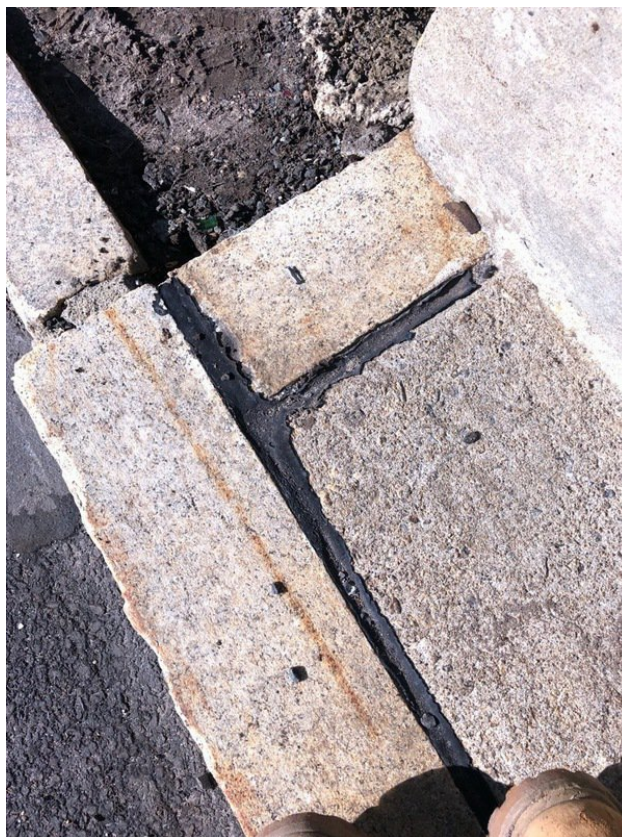
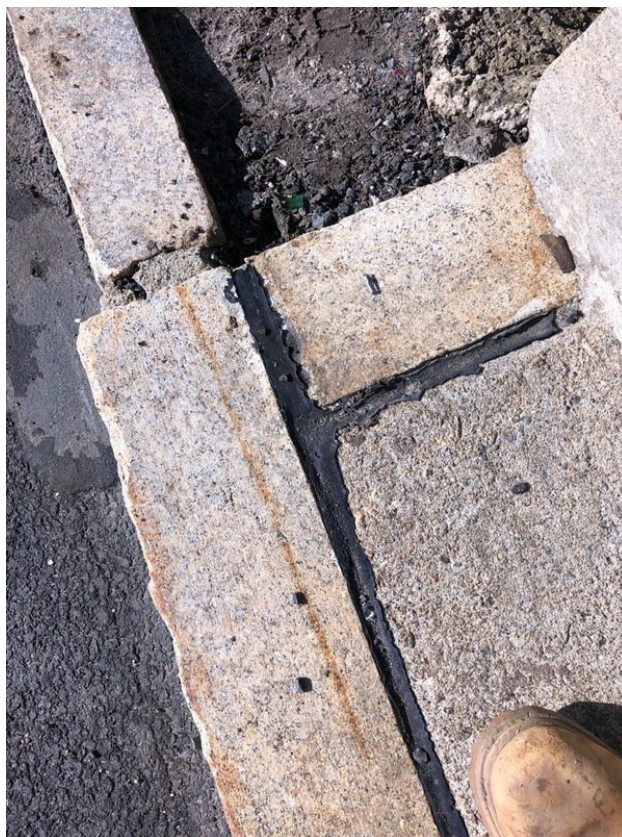
Route 8 south

(2), C, 3, Black sidewalk caulking, 2

Sampled or Assumed?	Sampled
Material Acronym	C, 3
Material Description	Black sidewalk caulking
Is Material a Non-Friable Organically Bound (NOB)	Yes
Homogeneous Area	Between every curb and sidewalk along bridges on both sides.
Total Approximate Quantity	2500 LF
Total Count	(2)
Total Count (number only)	2

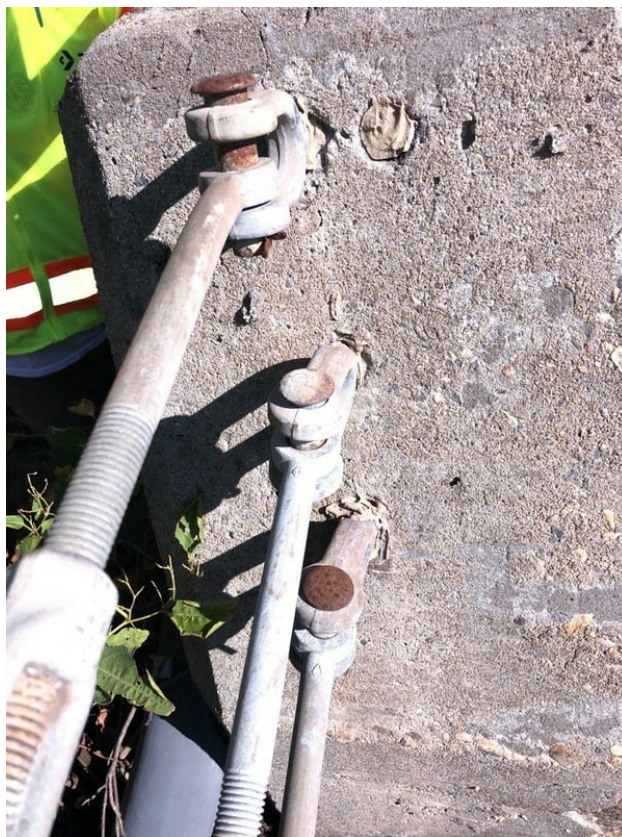
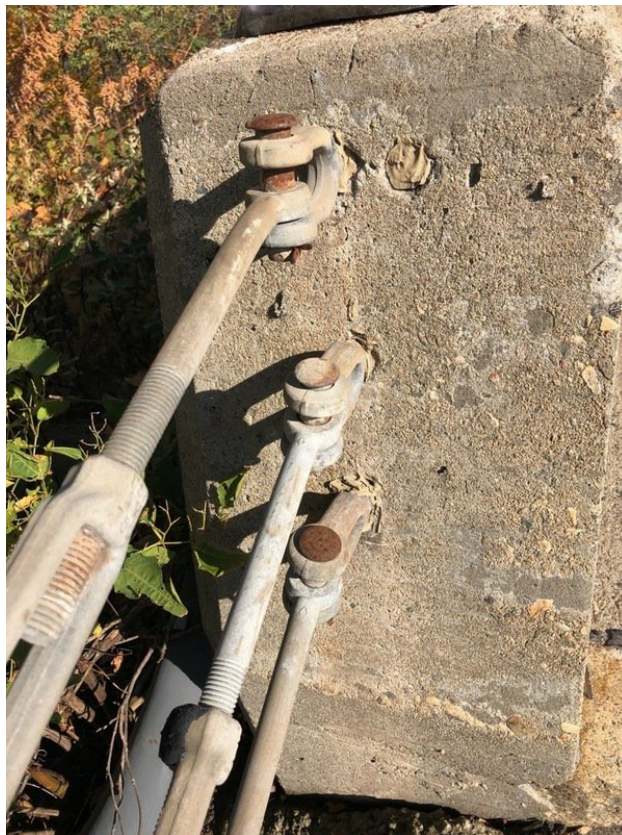
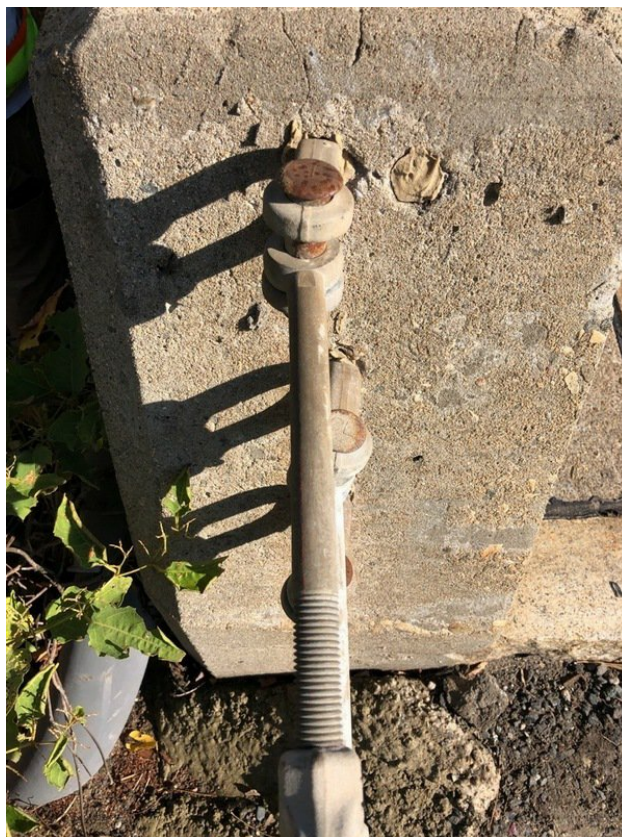
Route 8 south

(2), C, 4, Hard, off white caulk, 2

Sampled or Assumed?	Sampled
Material Acronym	C, 4
Material Description	Hard, off white caulk
Is Material a Non-Friable Organically Bound (NOB)	Yes
Homogeneous Area	Between wire fencing and concrete barriers on bridge. Assumed in every place where wire fencing meets concrete barriers
Total Approximate Quantity	25 areas
Total Count	(2)
Total Count (number only)	2

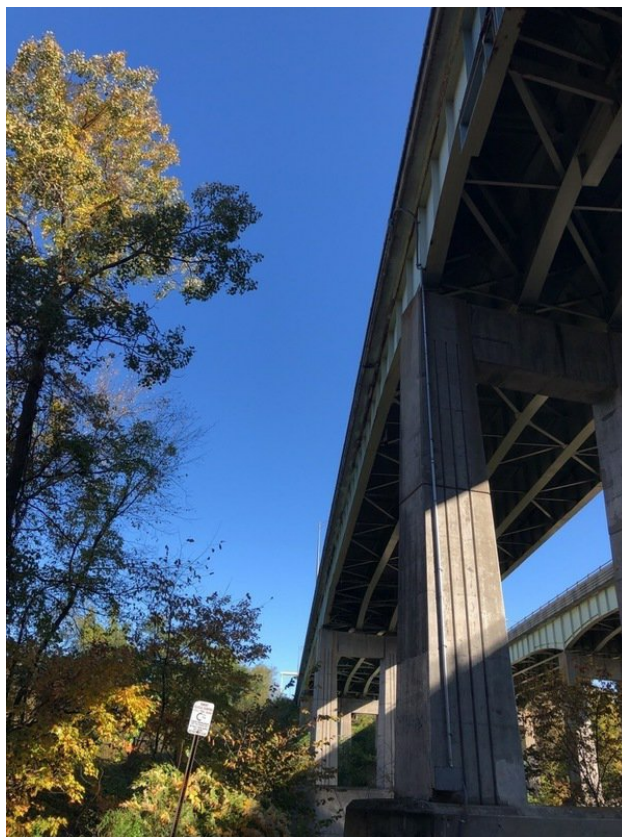
PI, 1, Pipe with black insulation running along the west side of route 8 South, 0

Sampled or Assumed?	Assumed
Accessibility	Inaccessible
Material Acronym	PI, 1
Material Description	Pipe with black insulation running along the west side of route 8 South
Is Material a Non-Friable Organically Bound (NOB)	No
Homogeneous Area	Along west side on route 8 south
Total Approximate Quantity	500 LF
Total Count (number only)	0

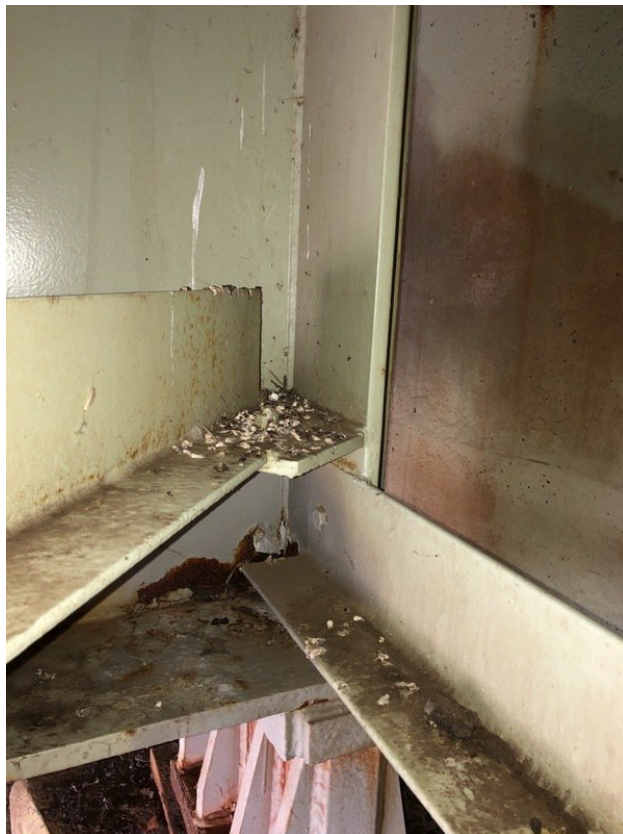
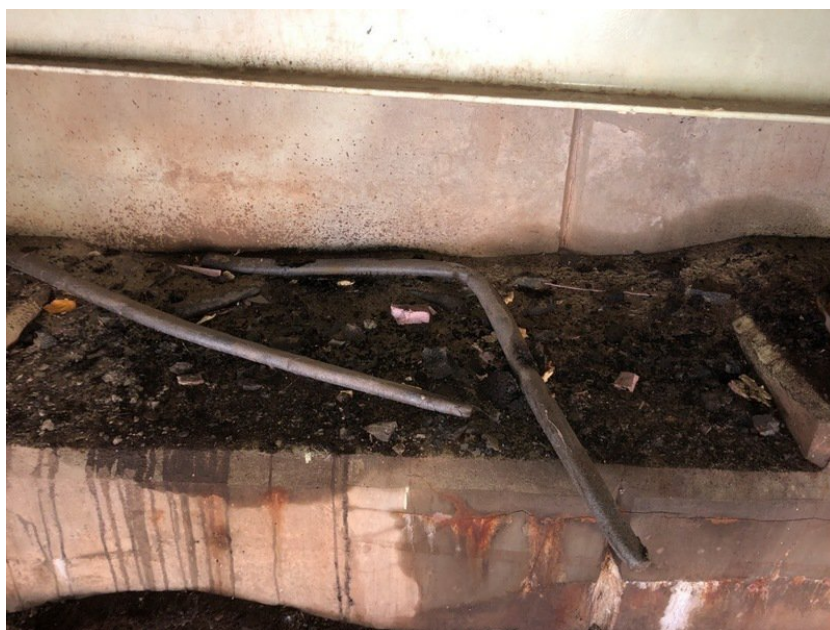
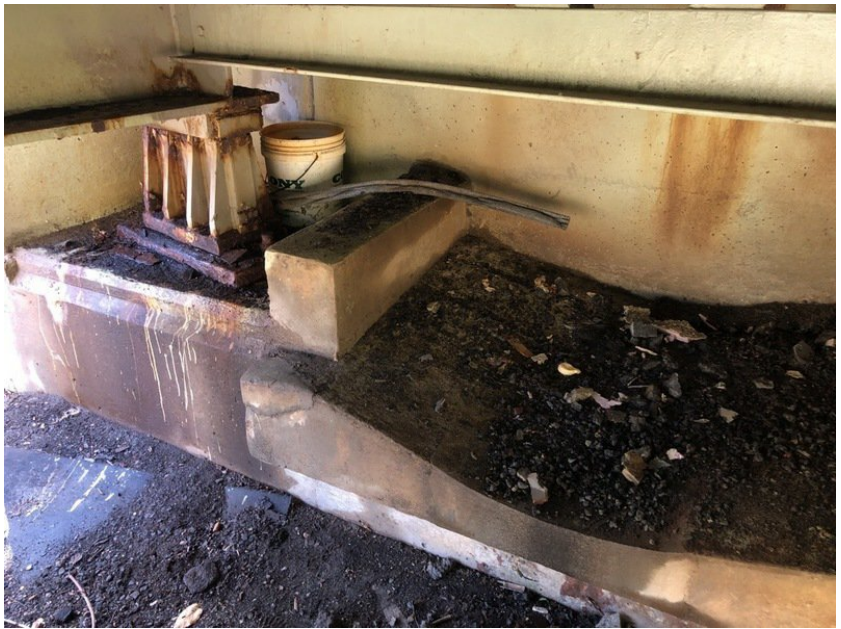
Under both bridges, south side

Miscellaneous, Guano/animal waste

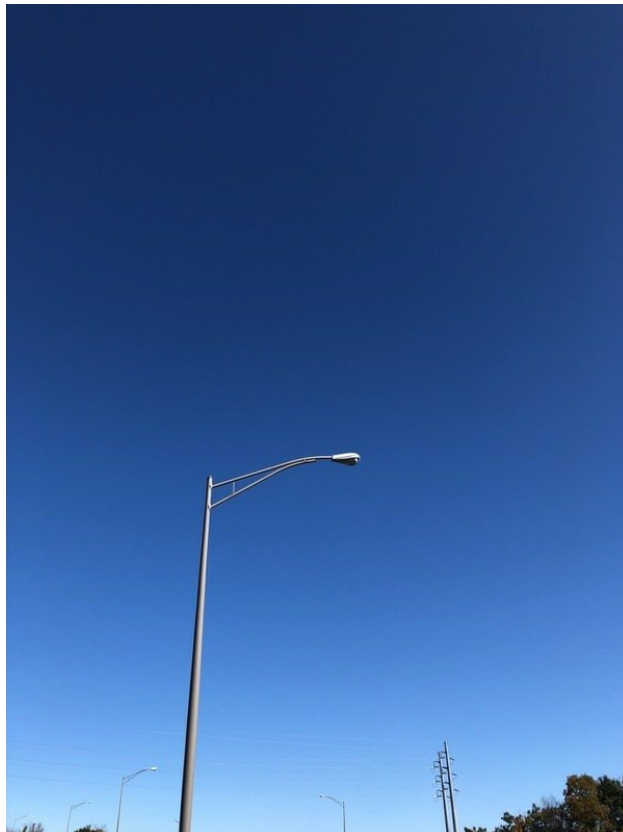
Universal Waste (UW), Fluorescent bulbs

Street lights
